**Re:** Withdrawal of Part 360 Permit Application  
NYSDEC Application Number 1-4736-00057/00001  
4 OLD COUNTRY ROAD, LLC  
76 North Summit Boulevard  
Westhampton, NY 11977

**MODIFICATION OF  
ORDER ON CONSENT**  
DEC No. R1-20080616-207

**Schedule A**  
**Modified Compliance Schedule**  
**4 Old Country Road, LLC**  
**DEC No. R1-20080616-207**  
**76 North Summit Blvd., Westhampton, New York 11977**  
**(“Facility” or “Site”)**

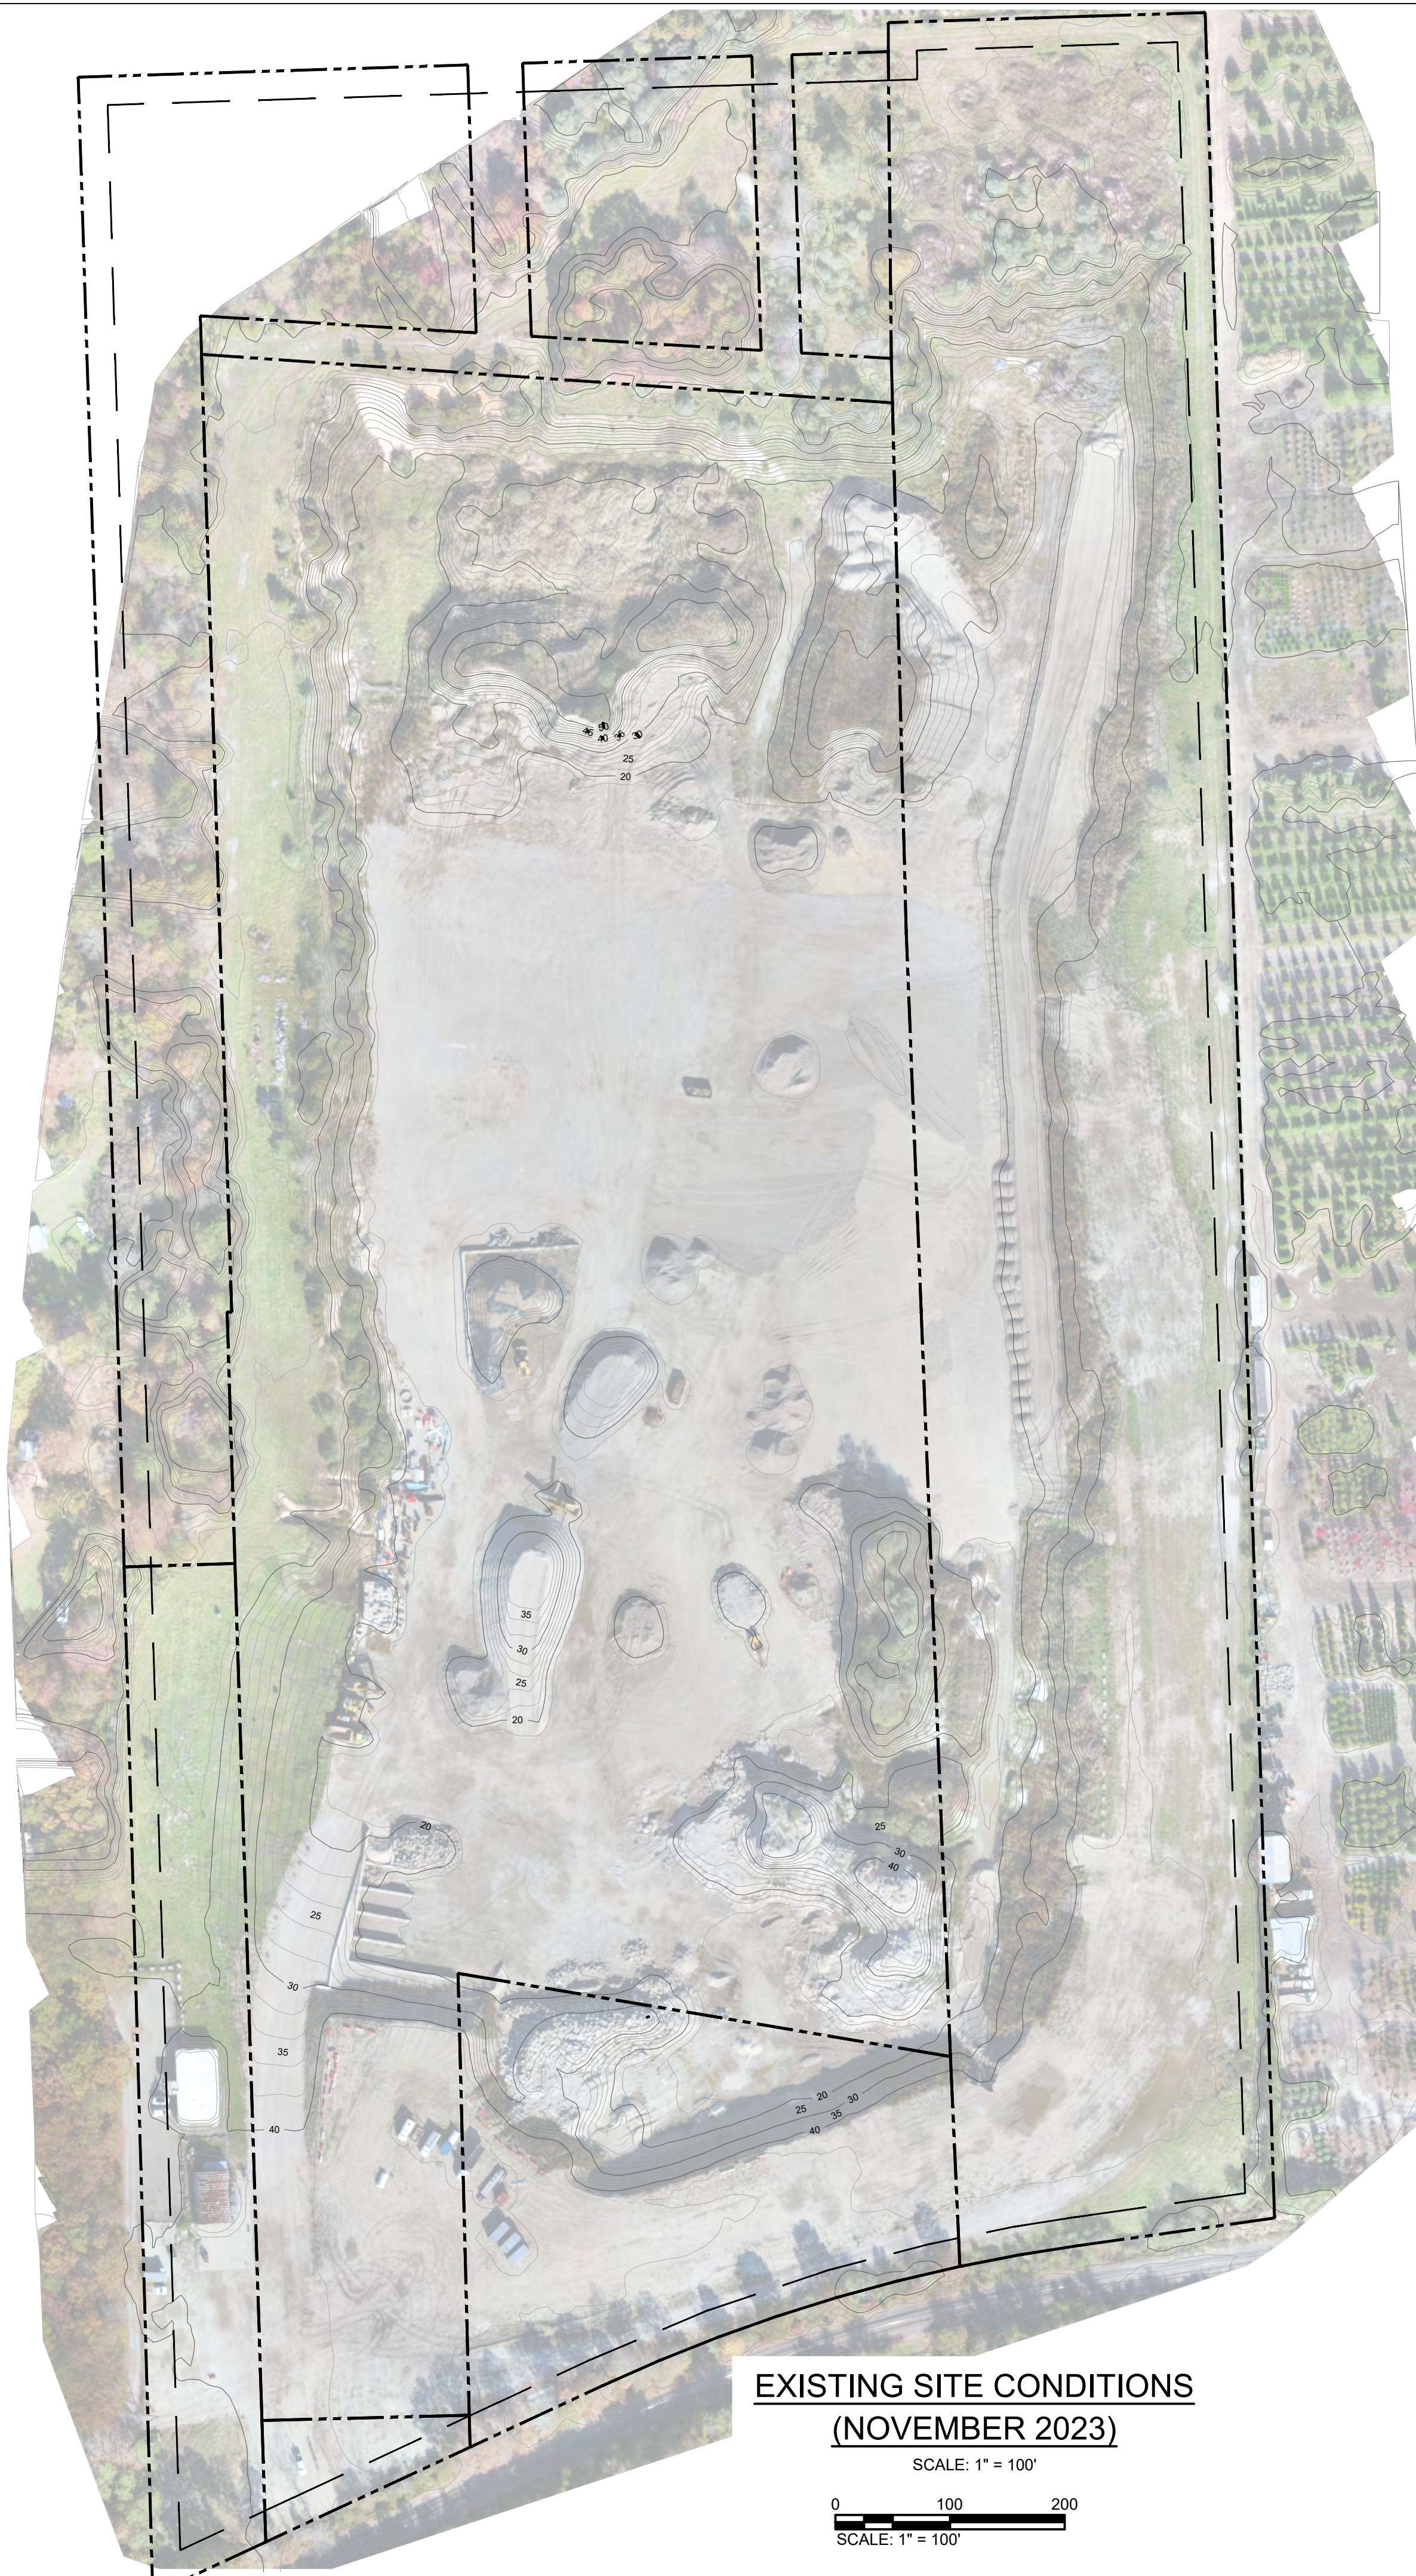
## EXISTING SITE CONDITIONS - NOVEMBER 2023

1. PROPERTY BOUNDARY FROM NEW YORK STATE GIS CLEARINGHOUSE - SUFFOLK COUNTY TAX MAP PARCELS.  
2. TOPOGRAPHY AND ORTHOIMAGERY DERIVED FROM A DRONE FLIGHT PERFORMED BY PWGC USING A DJI INSPIRE 2, DATED NOVEMBER 6, 2023.

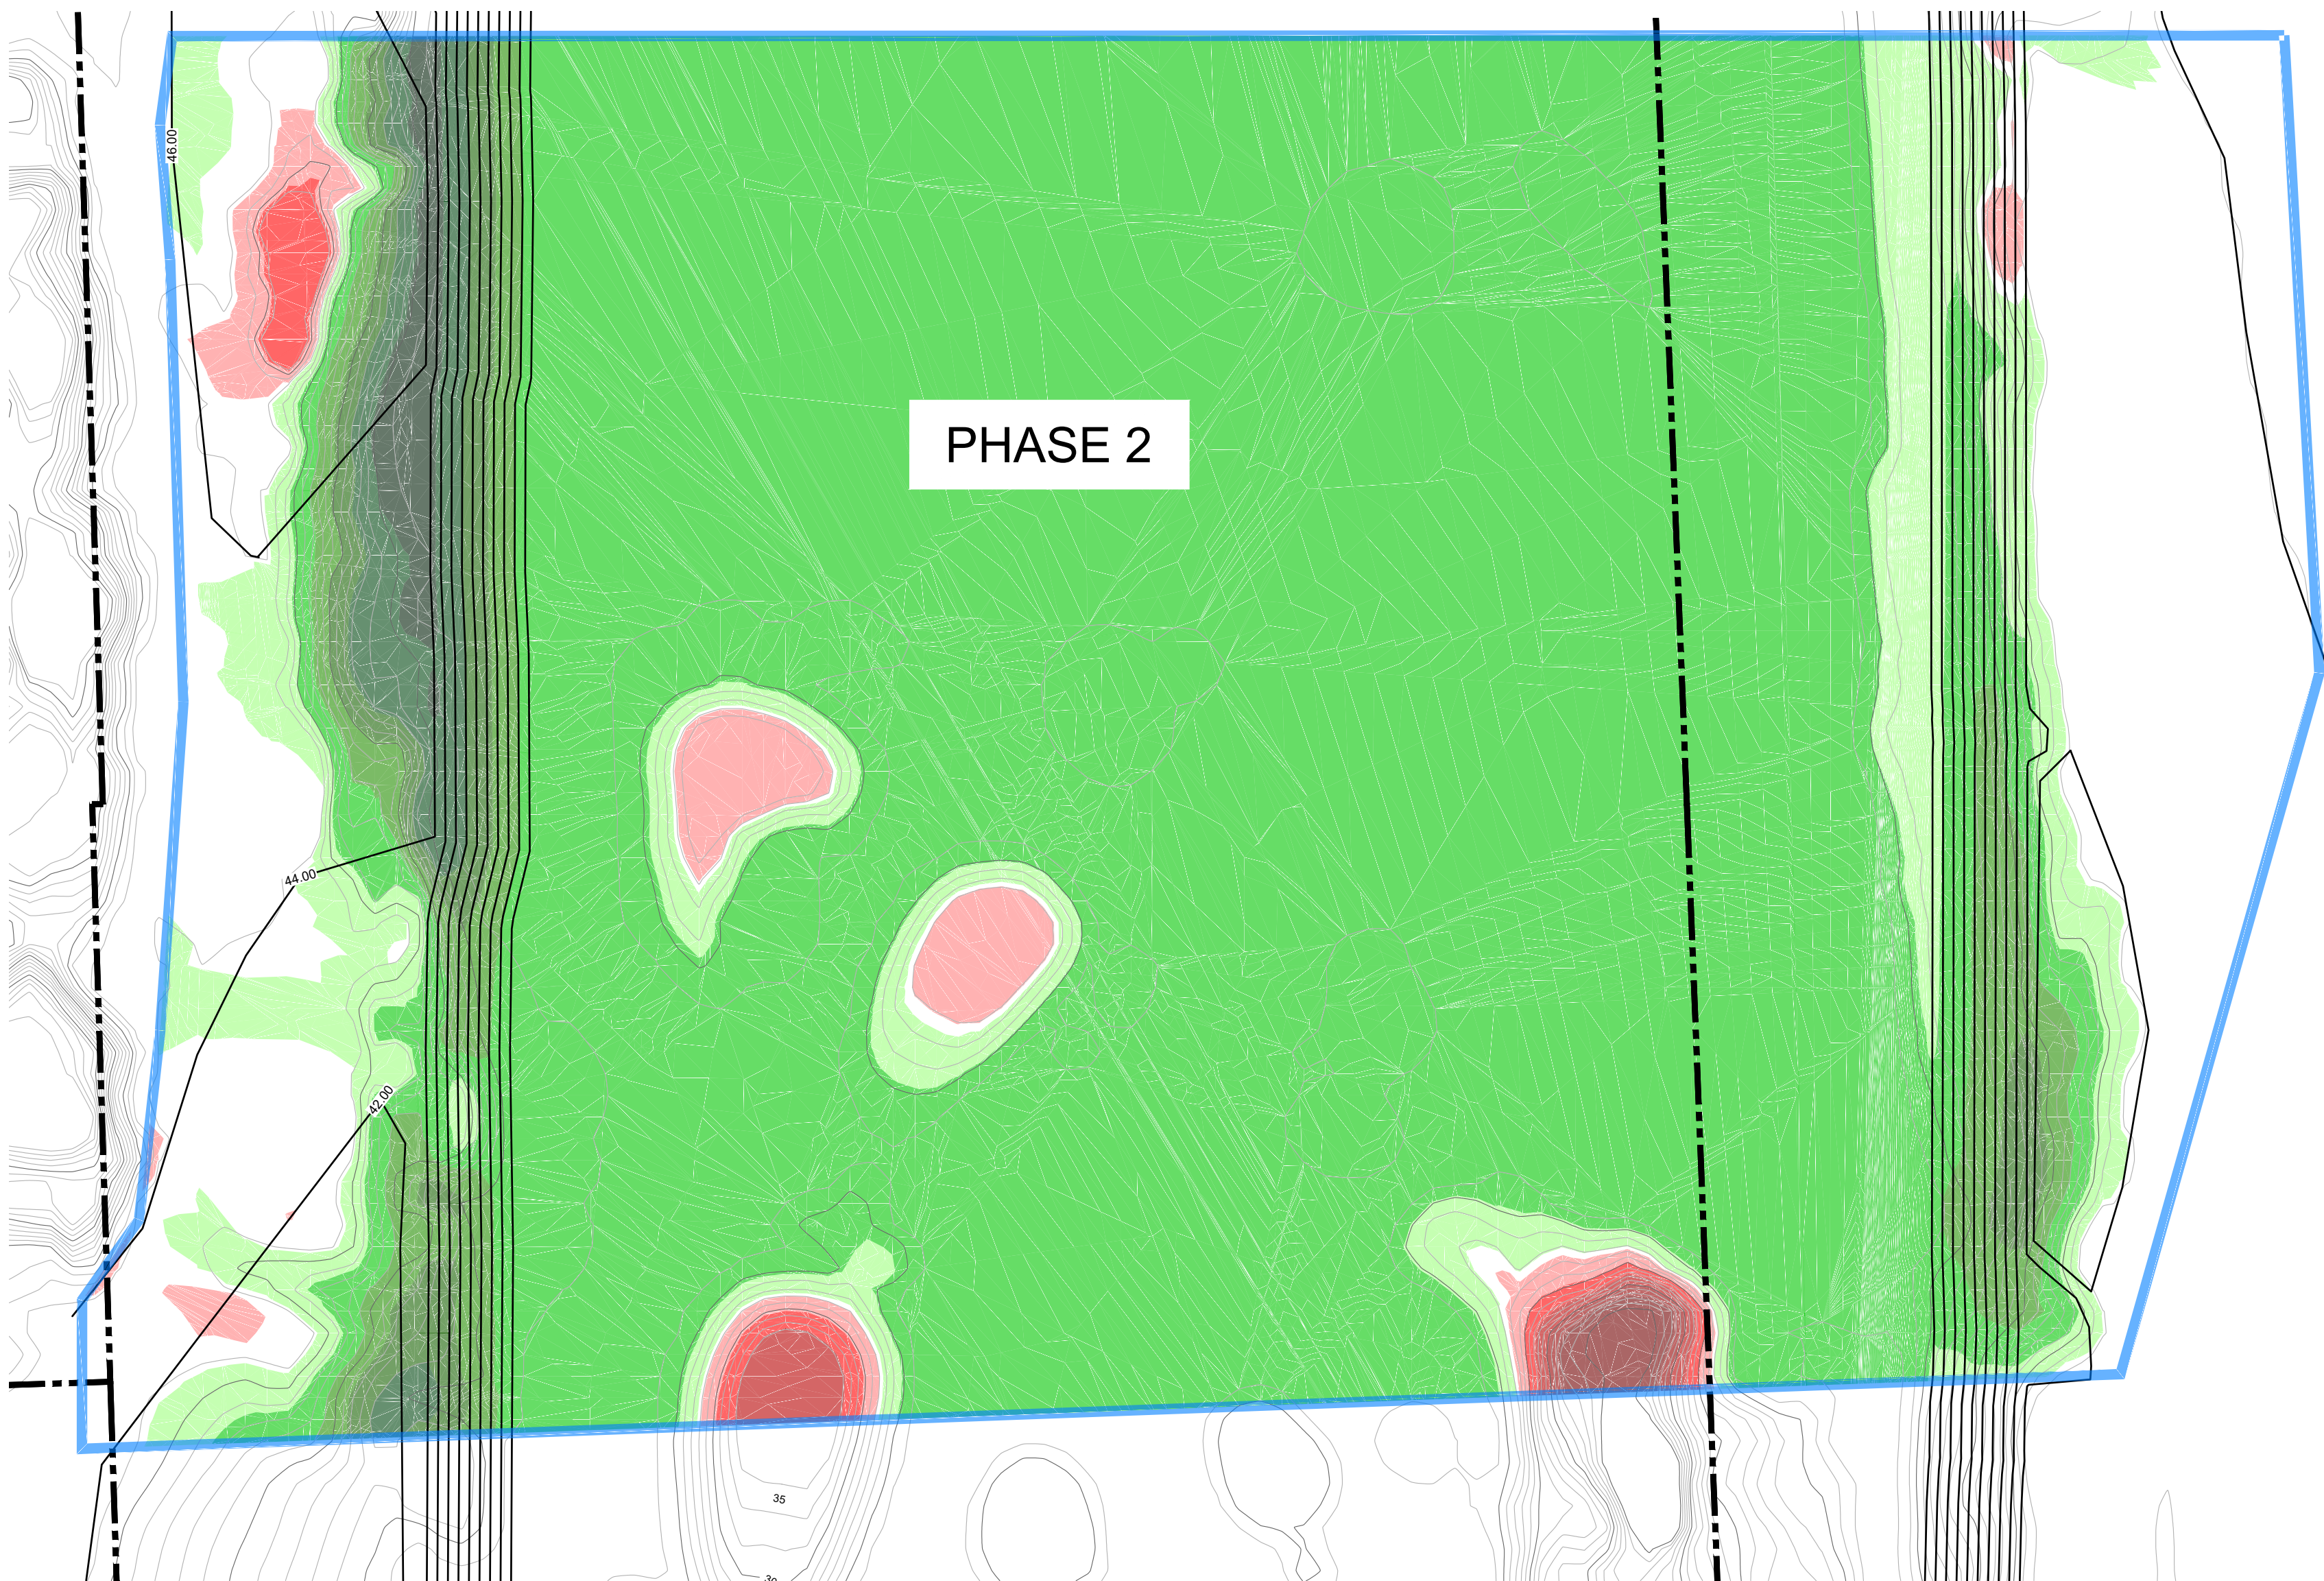
**PHASED PROGRESSION PLAN  
- PHASE 2**

FILL ELEVATIONS TABLE			
Number	Minimum Elevation	Maximum Elevation	Color
1	-25.413	-20.000	Dark Red
2	-20.000	-15.000	Red
3	-15.000	-10.000	Red
4	-10.000	-5.000	Red
5	-5.000	-0.500	Light Red
6	0.500	5.000	Light Green
7	5.000	10.000	Green
8	10.000	15.000	Green
9	15.000	20.000	Dark Green
10	20.000	25.000	Dark Green
11	25.000	28.001	Black
